Problems During the Throttle Body Production Process at PT HK Manufacturing

^{1,2,3,4,5,6}Universitas Pelita Bangsa

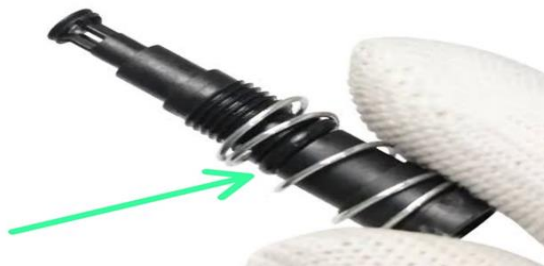
From the table above, it is concluded that the most problems are leaks that have been checked on the Leak Test machine. A leak in the Throttle body is the escape of air through an improper path. There are several causes of leaks as follows:

- Rubber seals that are damaged due to imprecise rubber seal installation.
- The diameter of the throttle valve that does not match its size causes a gap, resulting in a leak.

Figure 1. Rubber Seal Adjust Screw On Throttle Body

- a. To repair the leak, it is necessary to replace the rubber seal. For long-term repair, the rubber seal installation process must be carried out carefully, so that the seal is installed with precision and does not cause leaks.

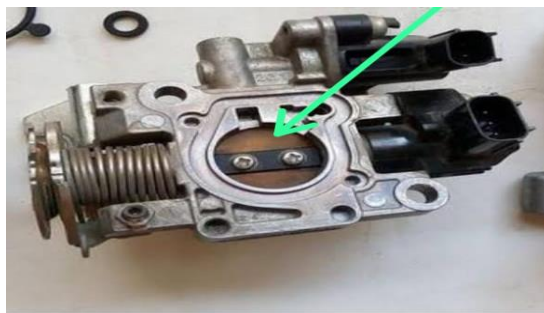
Figure 2. Throttle Valve On Throttle Body

- b. Measurement of the throttle valve at the beginning of the work, preventing the wrong size of the throttle valve.

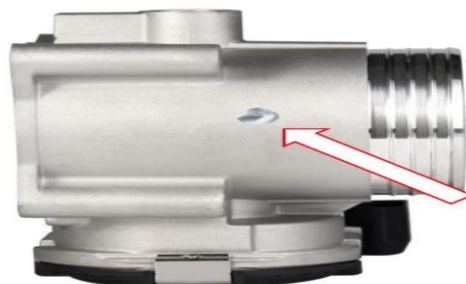
2. The dent is the indentation in the Throttle body. The cause is due to a collision in the production process. The impact is structural loss, aesthetic decline, economic loss, functional damage.

Figure 3. NG Dent on Throttle Body

1. Worker training: Train operators to handle components carefully
2. Use of the right tools: Using fixtures and jigs designed to prevent overpressure.
3. Safe packaging: Protect products with protective materials during transportation and storage.

For small dents, use methods such as light heating and leveling. Use a pneumatic dent remover for hard-to-reach dent areas. Sanding and smoothing: Sanding the dented surface until it is flat, then refinishing. Rewelding: If the dent is too deep, use welding and remachining.

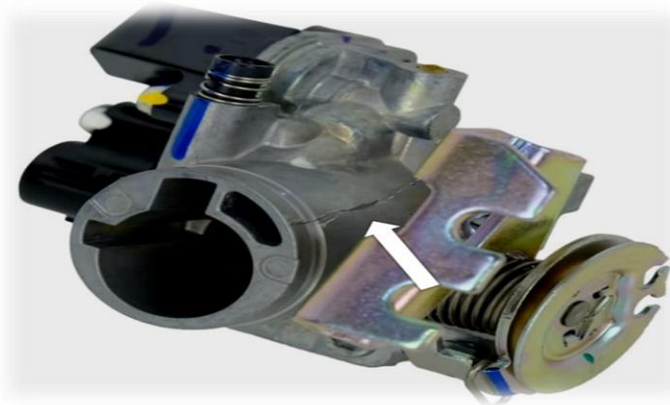
3. Yuhike is an NG body due to uneven melting temperature, the impact is structural loss, aesthetic deterioration, economic loss, functional damage.

Figure 4. NG Yuhike on Throttle Body)

Repair:

1. Rework: For minor defects, use processes such as polishing, grinding, or remachining. Re-coating to repair damaged surfaces.
2. Replacement of components: If the defect is too severe, replace the components with new ones to maintain the overall quality.
3. Welding or filling techniques. Use welding or filler techniques to correct structural defects, apply refinishing after repair to ensure uniformity.
4. Re-inspection: Use the Non-Destructive Testing (NDT) method to ensure effective repairs without damaging the product.
5. A pin hole is a small hole in the body that should not be there. The cause is air trapped during the smelting process. The impact is structural loss, aesthetic decline, economic loss, functional damage.

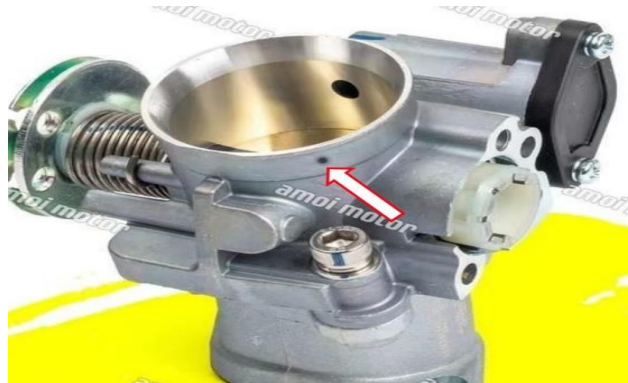
Figure 5. NG Pin Hole On Throttle Body)

1. Material cleaning: Clean the raw materials from contamination before use.
2. Optimization of the casting process: Use the right pressure and temperature.
3. Add ventilation or degassing to prevent gas from trapping.
4. Tool inspection: Make sure the tool and mold are free of dirt and defects.
5. Environmental control: Keep the humidity and temperature in the production area.

1. Refilling: Use a special filler material to seal the pin holes in the metal or coating surface.
2. Microwelding process: Use welding techniques on a small scale to seal the hole without damaging the surrounding area.
3. Additional protective layer: Apply a coating to hide and strengthen the pin hole area.
4. Additional inspection: Use non-destructive testing (NDT) techniques such as dye penetrant or ultrasonic to ensure the pin hole has been resolved.

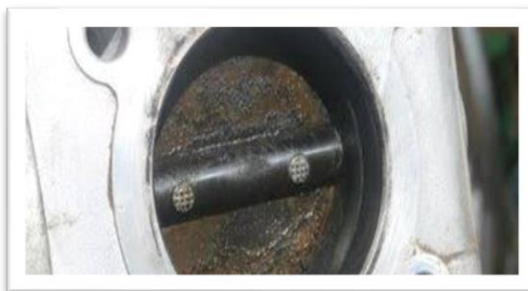
Rust is a corrosion product that forms on metal surfaces, especially iron and steel, as a result of chemical reactions between metals, oxygen, and water (or moisture). Rust often appears as a brittle reddish-brown coating and does not protect the metal from further damage. The causes are chemical reactions (iron corrosion), moisture, exposure to air and oxygen, damage to the protective layer, metal contamination. The impact is structural loss, aesthetic decline, economic loss, functional damage.

Figure 6. Rust on the Throttle Body

1. Choose products that are safe for throttle body components, such as mild acid-based anti-rust fluids (e.g., WD-40 or special rust removal fluids). Spray the liquid onto the rust-affected area, let it sit for a few minutes, and then scrub it using a soft-bristled brush or microfiber cloth. Use fine sandpaper or a soft wire brush.

2. For heavier rust, use sandpaper with fine grit (800*1000) to scrape away the rust layer without damaging the throttle body surface. Avoid excessive pressure to avoid eroding the metal material.

3. Coating
Once the rust has been removed, apply a protective coating to prevent rust from returning: Use anti-Rust paint or a sificon-based brace make sure the coating is even and does not interfere with the mechanical function of the throttle body

4. Replacement of Defective Components
If the rust is too severe and causes the throttle body to not function properly, consider replacing the throttle body with a new unit. Choose a throttle body with a rust-resistant material, such as anodized aluminum or metal with a protective coating.

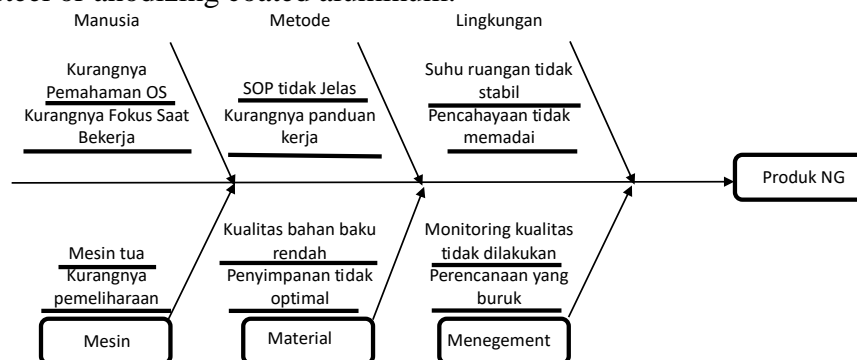
Figure 7. Fishbone Diagram

The fishbone diagram establishes failures in the production process as the main focus, which is placed at the head of the diagram. Meanwhile, "fish bones" describe the causes of problems based on factors such as man, machine, method, management, material, and environment.

1. In the human factor, it was found that the lack of understanding of OS for employees regarding machine operation and correct work procedures was the main cause. The high turnover rate disrupts the stability of the workforce, while non-compliance with standard operating procedures (SOPs) also worsens the situation. PT HK Manufacturing addresses this with a policy of assigning employees in the quality assurance department or management to oversee the production process. This step aims to prevent production failures that lead to defective products (NG) due to exceeding the limits of inspection standards. With regular supervision, the risk of increasing the number of defective products can be minimized.

2. In the machine factor, it was found that equipment that does not meet quality standards, the absence of a routine maintenance plan, and the use of old machines that are forced to continue working can cause sudden damage. This has an impact on decreasing product efficiency and quality.

3. In terms of material factors, the use of raw materials that do not meet standards affects the production process and final results. Storage of raw materials that do not take into account temperature and humidity can cause material damage, such as deformation, which ultimately degrades the quality of the product.

4. In the method factor, the lack of standard work guidelines can cause inconsistencies in the production process. The absence of continuous improvement, structured quality control, and inefficient work processes slow down production.

5. In environmental factors, elements such as temperature, humidity, and lighting affect the production process. The quality of raw materials can deteriorate, and poor lighting in the production area reduces the operator's ability to detect defects in the product, thereby increasing the risk of undetected defects.

6. Finally, in the management factor, poor planning results in unrealistic production schedules, causing delays. Lack of quality monitoring and the absence of periodic evaluation to detect and prevent problems are additional causes in the decline in the quality of the production process.
