Preventive Analysis of Polymer Leakage in Injection Molding Machines and Its Impact on Production Efficiency

Abstract

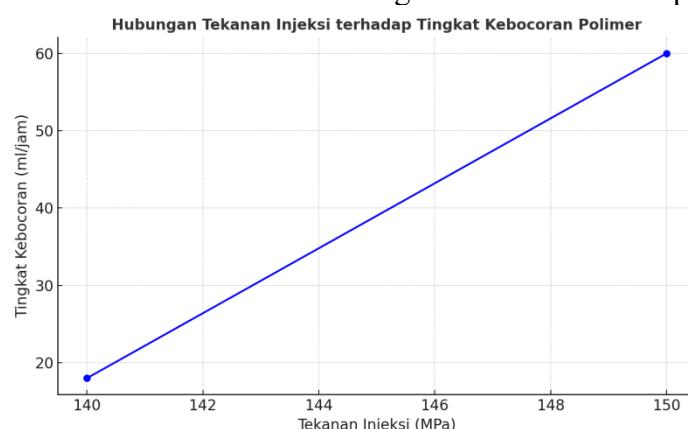
Figure 3. Injection Pressure Diagram

The following line graph shows the relationship between injection pressure and polymer leakage rate in an injection molding machine. It can be seen that when the injection pressure is reduced from 150 MPa to 140 MPa, the polymer leakage rate is significantly reduced from about 60 ml/h to 18 ml/h, indicating the effectiveness of process parameter optimization.

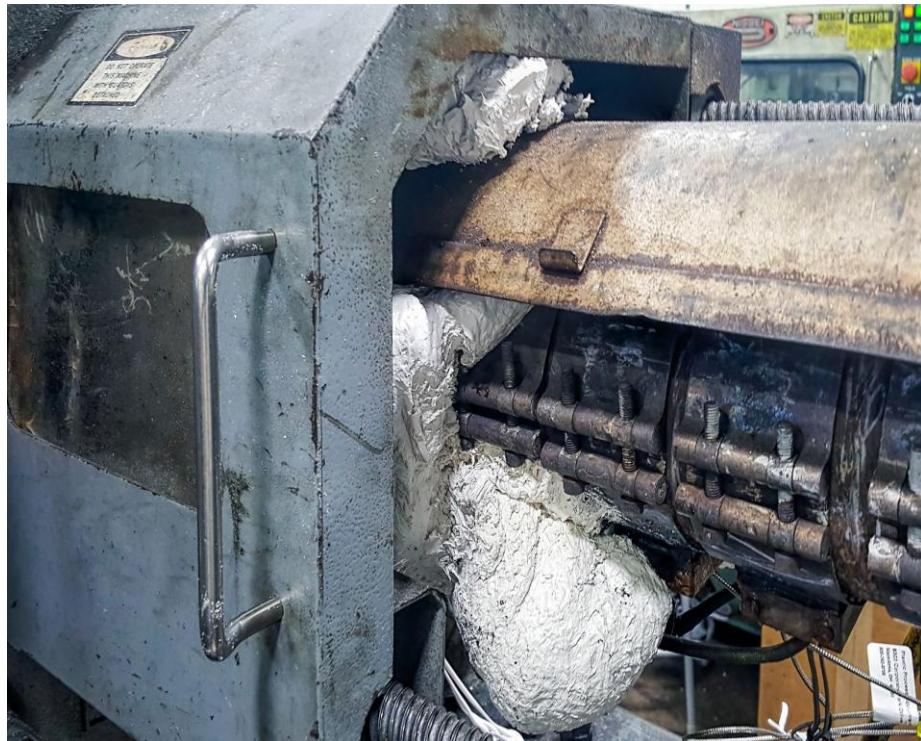
Inspection results on a 500-ton injection molding machine model showed that polymer leakage occurred in the nozzle connection area. Sprue bushing. Liquid ABS polymer was detected leaking at a rate varying between 20–100 ml/hour. depends injection pressure. Measurements show:

- Actual injection pressure: 150 MPa
- Liquid polymer temperature: 250°C
- Nozzle position deviation: 0.25 mm from the mold axis
- Seal condition: shows wear and micro-cracking after 500 simulated production cycles .

Figure 5. Polymer leakage in the injection molding machine

1. Seal replacement and joint repair.
2. Routine calibration of sensors and process parameters.
3. Operator training for better visual and technical control.
4. Improve ventilation and room temperature control.

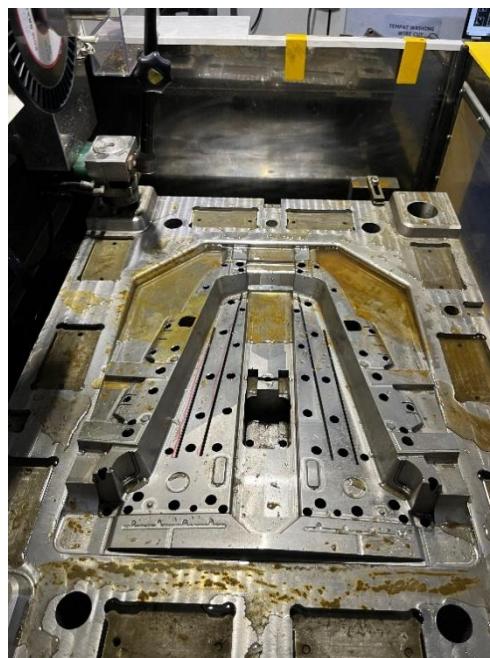
Figure 6. Repair core insert molding

Molding Repair Steps The following are the detailed steps that technicians usually carry out:

1. Welding / Build-Up

- TIG welding or laser welding to rebuild worn areas.
- After that the area is re-machined until it is close to the original size.

2. Machining / Refitting Repair with:

- Milling, grinding, EDM to restore the shape and tolerances to the original design.

3. Detailed Inspection:

- Checking surface flatness.
- Measuring wear on core & cavity.
- Check ejector pin, bushing, guide pin, and alignment location.

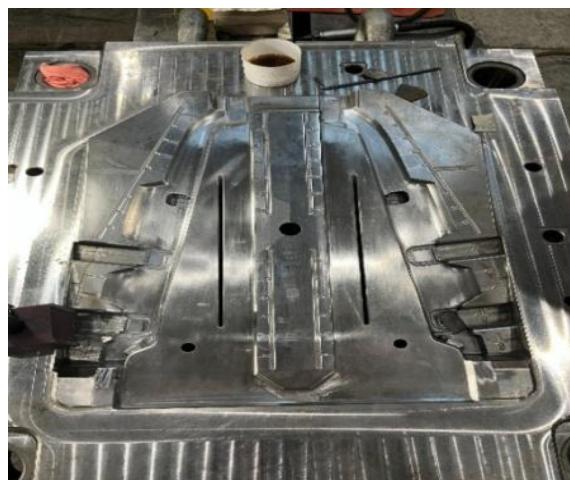
Figure 7. repair cavity insert molding

If the mold in the photo is not repaired, potential problems include:

- Defective molded products (flash, short shot, warpage)
- Cycle time increases
- Mold is stuck or difficult to close
- Greater risk of damage and increased repair costs

1. Cleaning (Total Cleaning)

- Clean rust with rust remover or degreaser fluid.
- Cleaning the cooling channel (cooling channel flushing).
- Removes plastic, oil and coolant residue.

2. Polishing

If the cavity surface is scratched or dull, a polishing process is carried out.

- Stoning
- S and paper finishing
- Polishing diamond paste to restore surface smoothness.

3. Replacement

Worn components are replaced, such as:

- ejector pins
- guide pins
- bushings
- springs
- cooling fittings

4. Preventive Maintenance

After repair, the mold is usually given:

- anti-rust lubricant
- cavity protective oil

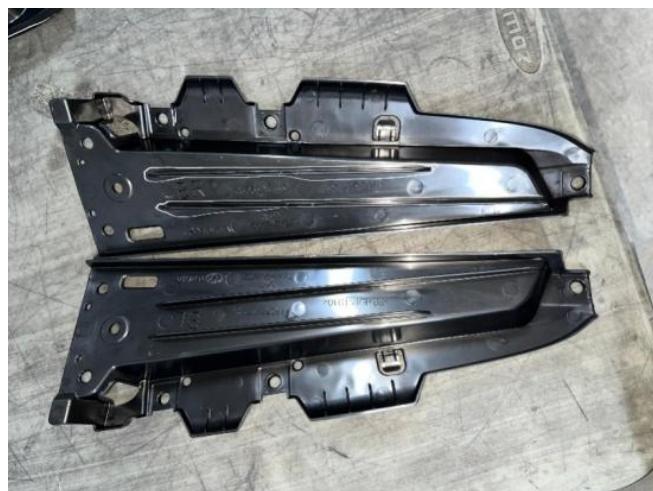
Figure 8 Product results in molding

Molding is a production method used to shape raw materials, such as plastic or metal, into products of specific shapes and sizes using rigid molds. A variety of products can be produced using various molding techniques, such as injection molding, blow molding, and rotational molding.
